REAR AXLE OIL LEAKS AND RELATED ISSUES

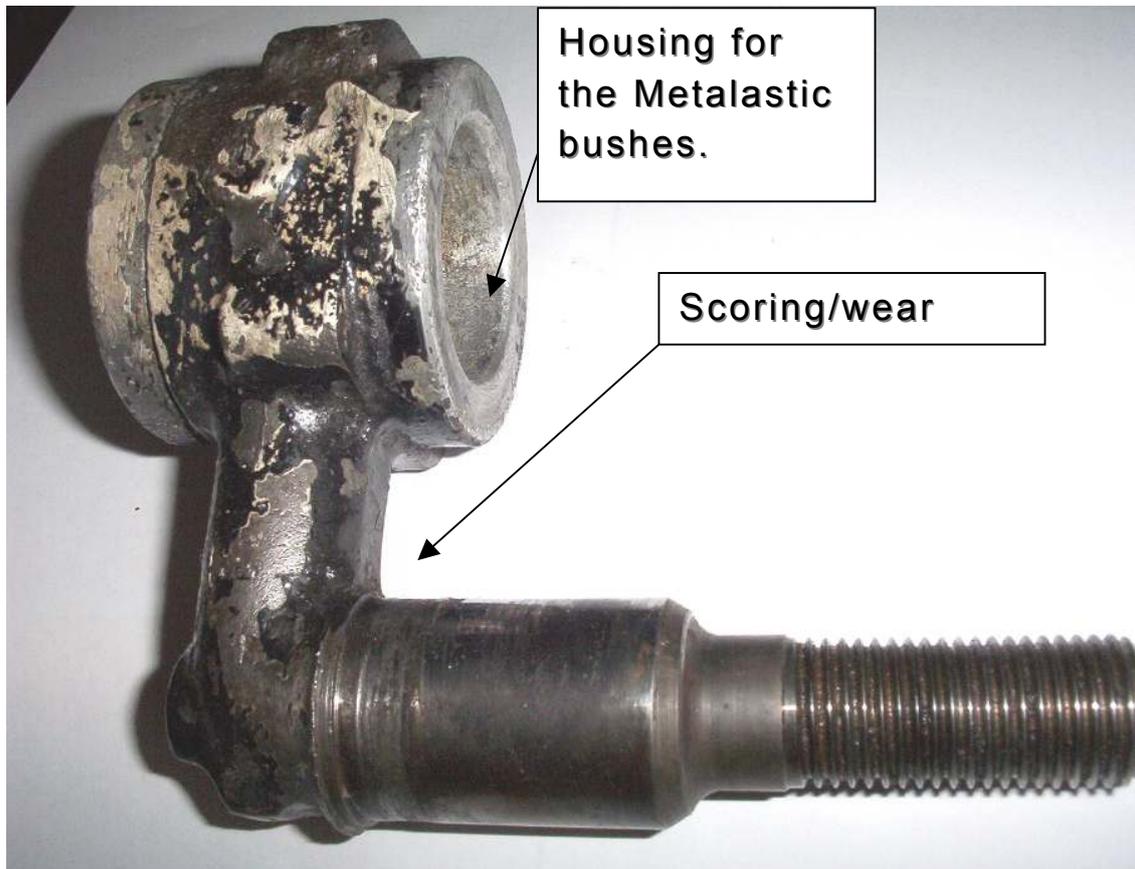
LH Swivel shaft assembly

Both of the shafts were machined to 29mm diameter to match the size of a modern oil seal, readily available from a specialist supplier, and to remove deep scoring as can be seen in the above picture. Both the original LH brass bush, and the new RH part were dimensionally too small to take the proposed oil seal after re-machining, so the bushes were re-designed with an open end to accommodate a press fit for the new oil seals. A local engineering company, then produced the parts turned out of brass. The internal diameter was allowed to be 0.2mm larger than the shaft diameter, so that when the bush was pressed into the axle, the shrinkage across the diameter achieved a snug fit when the swivel shaft was inserted.

No information as to why the drop arm shaft was tapered could be found, as there was no reference to it during my deliberations. However, modifying the dimensions was pondered for a while, as it could affect the alignment and stability of the axle under suspension loading, whilst the car was being cornered for example. Eventually, I decided to have the shafts machined to

29mm diameter, to removed the scoring marks, and give a smooth finish for the new oil seal lip. Apart from making the shaft non-tapered, the amount turned off in the lathe was about 1mm. This small change would not compromise the mechanical strength of the shaft.

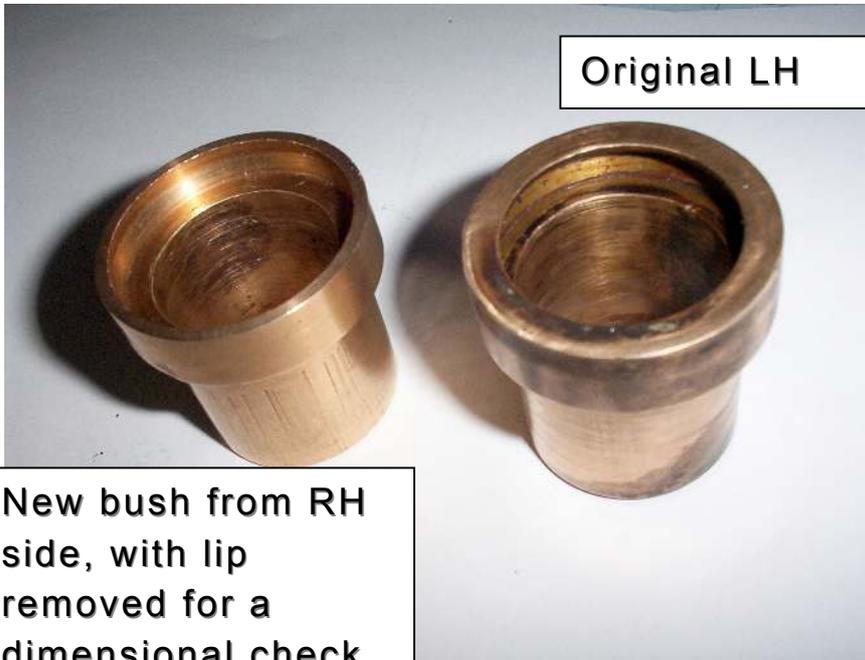
Original LH

New bush from RH side, with lip removed for a dimensional check for modern oil seal fitment.

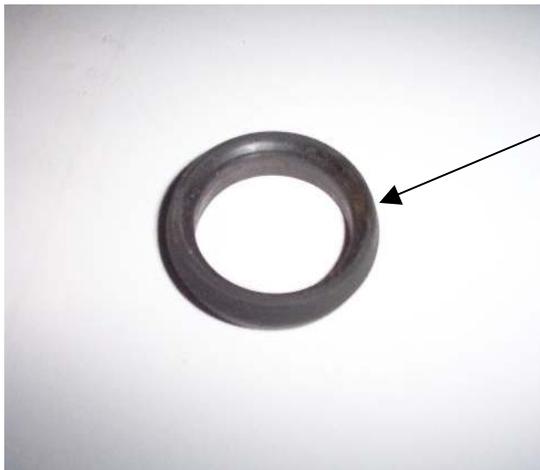
Original pattern

Modern type showing lip spring.

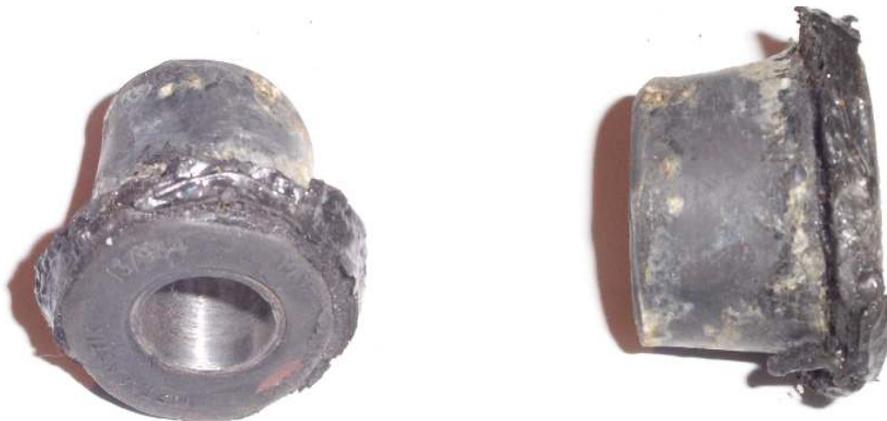
One other issue that appeared when the axle was removed, was the poor condition of the drop arm Metalastic bushes. The inner spacer tubes originally bonded to the rubber cones, had become detached, and on the RH side, one remained on the drop arm shaft when the axle was removed. After a squirt with WD40, it was extracted intact. Having made some enquiries with my motor industry contacts, it became apparent, that these particular Metalastic items were not available, as I suspect the tooling had been destroyed some time ago when Metalastic was taken over by Trelleborg. (When the car was running, the axle noise had become quite intrusive between 35 and 55 mph, and although the axle oil was changed to a multigrade EP with a molyslip additive, there was no discernable improvement.) The dimensions of the bush were taken from the most intact item, and compared to the swivel arm housing dimensions.

The most intact bush removed from the swivel

A length of polyurethane bar was obtained, and the bushes were machined to the drawing made of the above. To achieve a good compliance, and to ensure that the ride quality was not compromised, SPROD2-90 Shore was used. The only problem encountered with this material was, that it needed to be placed in a deep freeze 48 hours prior to machining, to prevent drift at the cutting tool. An initial sample was made to check the dimensions against the swivel shaft housing, this proved to be acceptable, and four more bushes were machined. Finally, the spacers were

removed from the original Metalastic bushes, cleaned, and pressed into the centres of the polyurethane bushes. The parts were given a final dimensional check prior to fitting, and all items such as the drop-arm shafts, were cleaned in preparation for re-assembly.

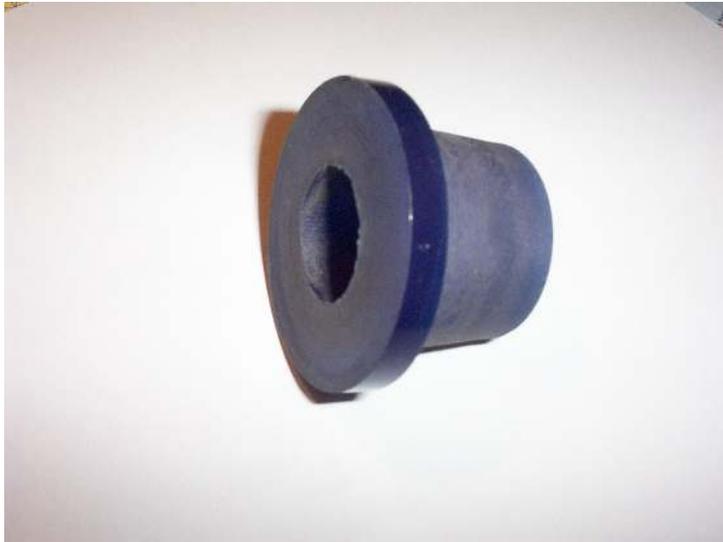
The polyurethane bush before the original steel spacer was pressed into the centre. The bush was machined to a 1.0mm under size, so that when the metal spacer was pressed

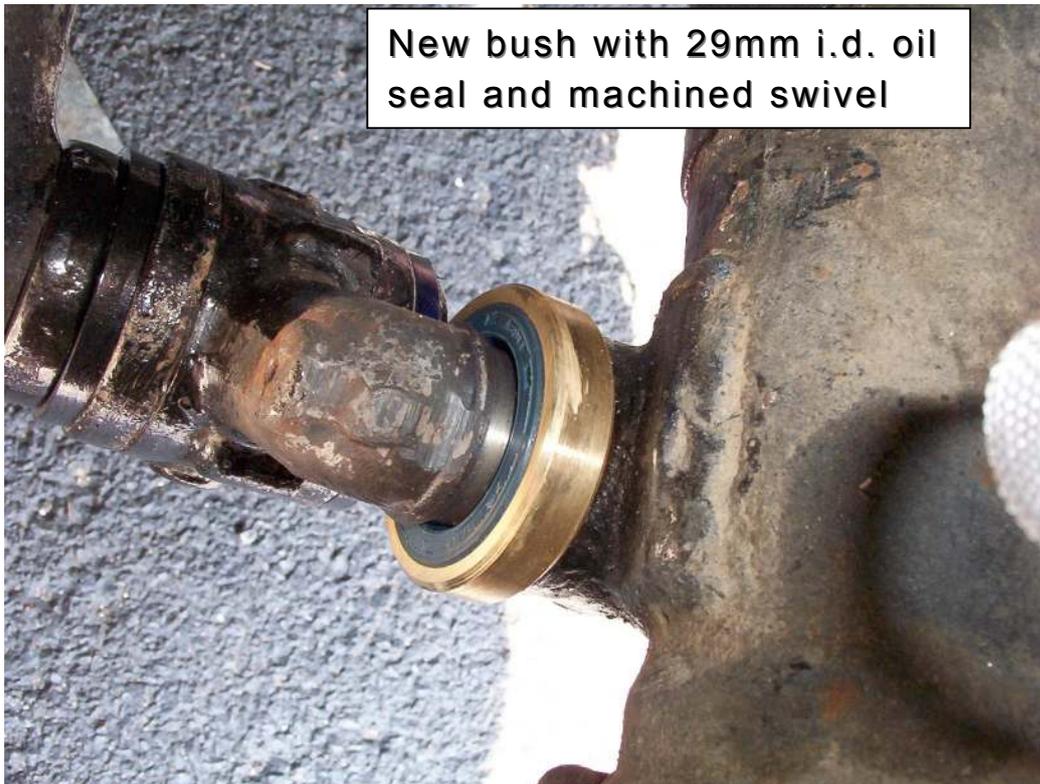
New bush with 29mm i.d. oil seal and machined swivel

The oil seal was pressed into the end of the bush with a smear of Hylomar on the outside circumference, to ensure that the fit was oil tight. The new polyurethane bushes were assembled on to the drop arm shafts, and then the shafts plus bushes and swivel shaft
